## Case Report

### Endovascular Management of Subclavian Artery Injury due to Hickman Line insertion in a patient with coagulopathy

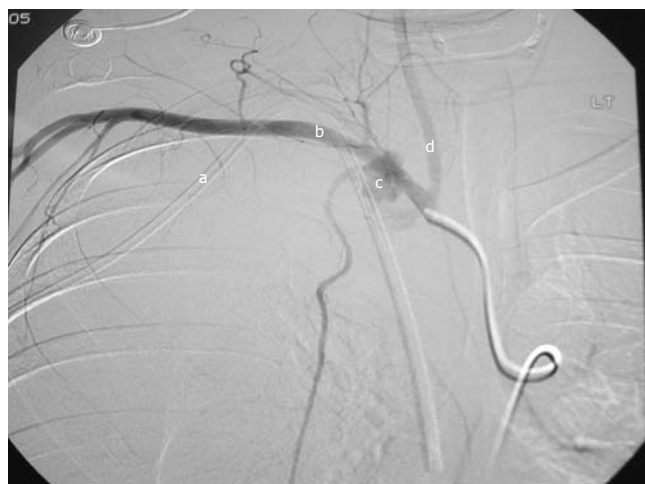
Figure1. Contrast leak from proximal subclavian artery on angiography a-Hickman line, b- Subclavian artery, c- Contrast leak on DSA, d-Vertebral artery.

After a discussion between the Vascular Surgeon, Cardiothoracic Surgeon and Interventional Radiologist, the patient underwent a right subclavian artery angiogram, revealed a puncture in first part of right subclavian artery just distal to origin of right vertebral artery (Figure 1). Using an endovascular approach a covered

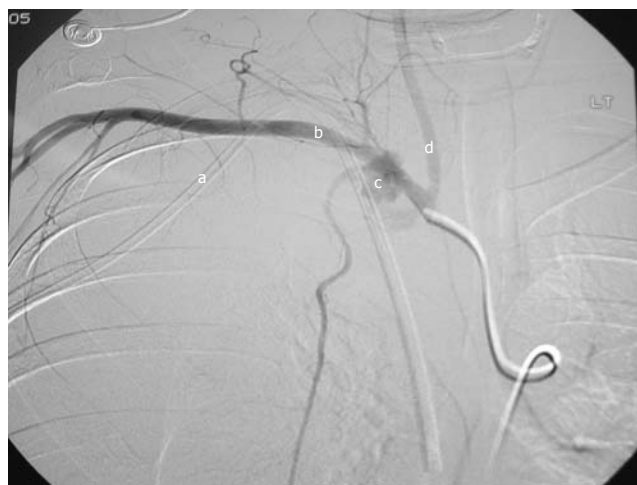
Figure2. Post procedure angiogram a- Hickman line, b- Endovascular cover stent in situ, c- Patent vertebral artery, d- Subclavian artery, e- Common carotid artery.

Palmaz stent was placed over the puncture site to stop the leak. A post procedural angiogram (Figure 2) confirmed successful covering of leaking segment of right subclavian artery. Patient was kept in the intensive care unit for 24 hours. She recovered well and chest drain was removed after 48 hours. Her chest x-ray showed normal chest expansion on 3rd post-procedure day.
